## **Urban ecology: a case study in how to improve urban biodiversity.**

### **Background**

### Findings

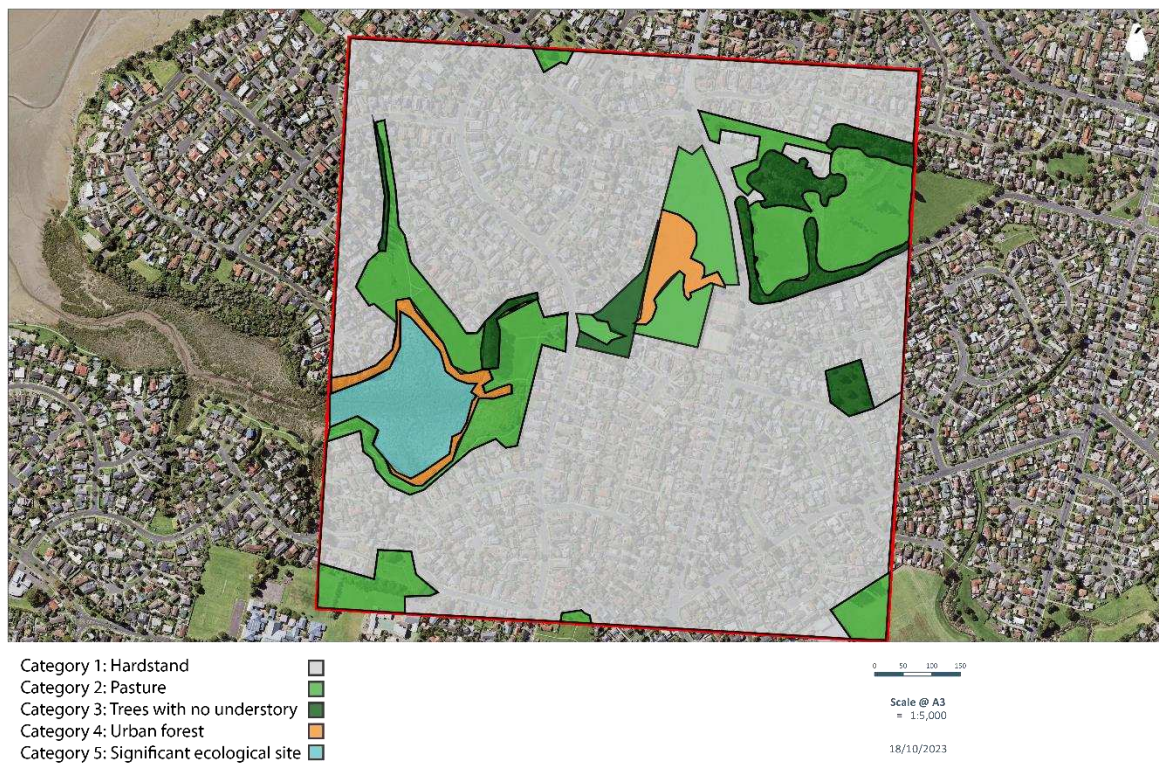
**Figure 2:** *Categorisation Map*

After measuring the percentage cover of all categories (as seen in Figure 2) using satellite imagery, the multiplier values were used to reach a final biodiversity value of 65.38 out of 160, as seen in Figure 3.

The percentage cover of various categories within the site was quantified to assign a numerical value to the area's biodiversity. This was done utilising satellite imagery from 2017. These categories include hardstand areas with impervious surfaces, such as roads and buildings, which receive a biodiversity multiplier of zero—Pastureland, which receives a 0.2x multiplier for biodiversity value. Trees with no understory receive a 0.3x multiplier. Urban forests receive a 0.6x multiplier for biodiversity, and ecologically significant areas, such as the mangrove forest and scrub with the case study site, receive a multiplier of 1x.

The immediate surroundings of the waterways are also categorised, and immediate hard stand surrounding waterways received a multiplier of 0x, pasture or trees with no understory a multiplier of 0.3x, and forest and ecological sites surrounding waterways a multiplier of 0.6x.

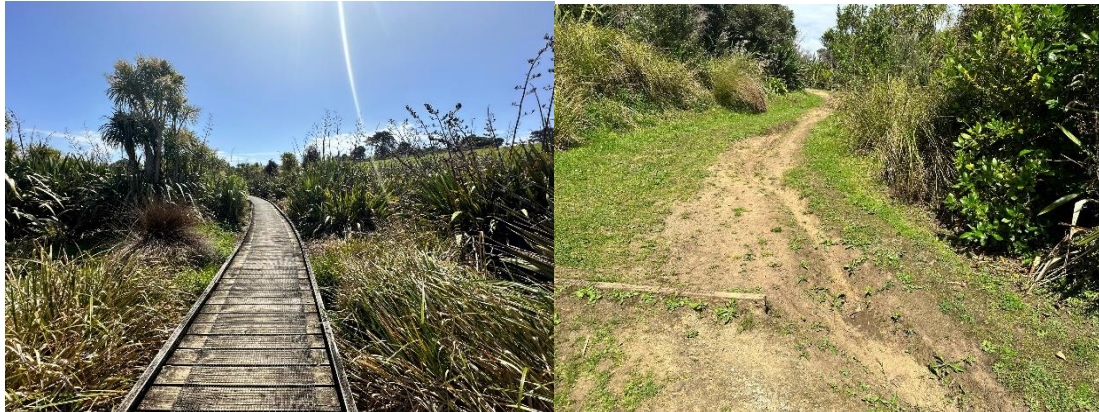
**Figures 8 & 9:** Photos showing the wetlands and tracks of Pigeon Mountain

Wetlands such as this provide a habitat for native plant species such as Toetoe, Harakeke, and Ti Kouka and native bird species such as Kotare, Pukeko and Mataka-moana. The elevated walkway transforms into a well-trodden muddy path, which climbs the hill towards Pigeon Mountain Hill as seen in Figures 8 and 9. Trash, such as road cones, were observed in and around the wetland.

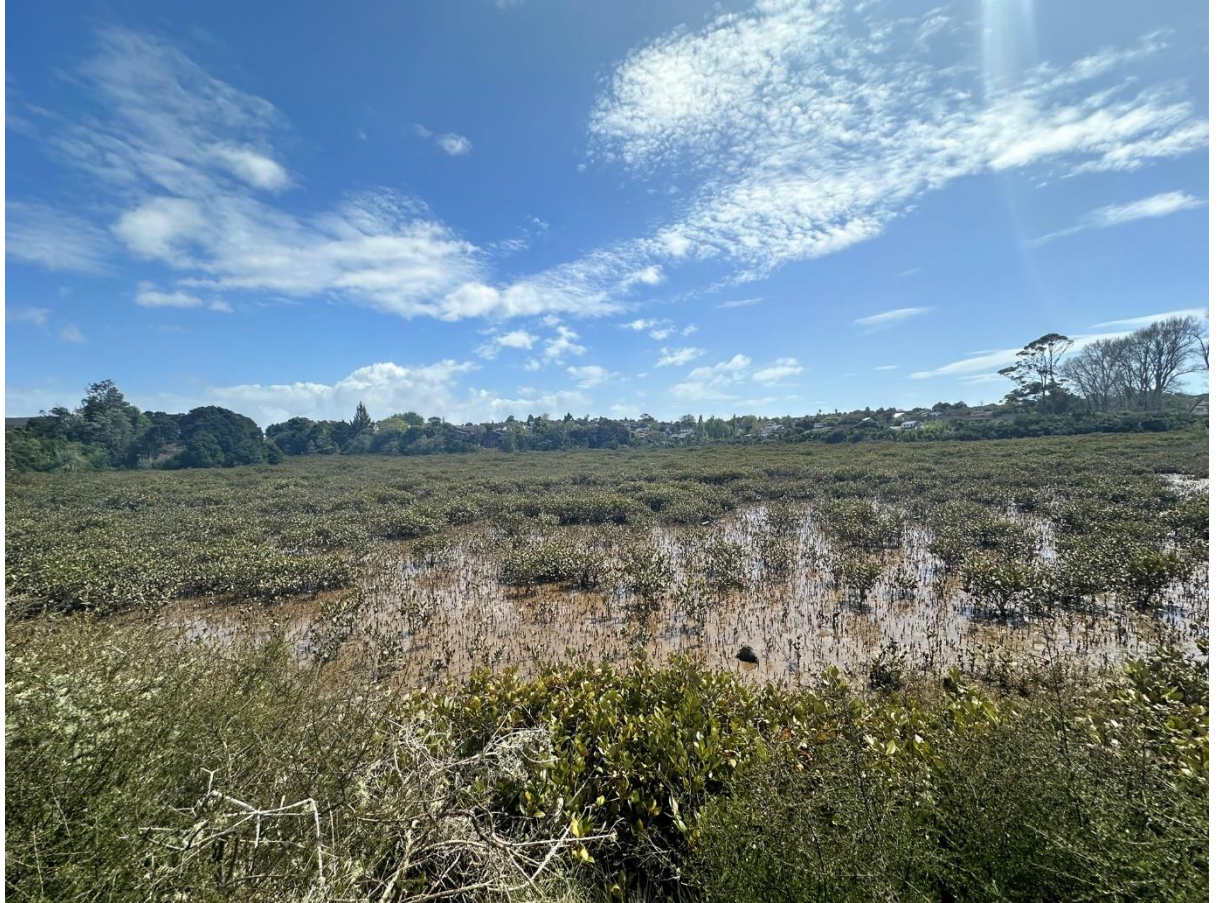
**Figure 11:** *Photo of mangrove scrubs*

There was a large amount of mangrove scrub that kept going on and on along the coastline as seen in Figure 11.
