# **Site Analysis: University of Auckland City Campus: 100 Sector**

Arson Rashidmardani

This study aims to analyse the 100 Sector of the University of Auckland's city campus to understand the site's historical, regional, and environmental context. Findings from the site plan will help determine the sector's strengths and weaknesses and provide guidelines for future synergistic development.

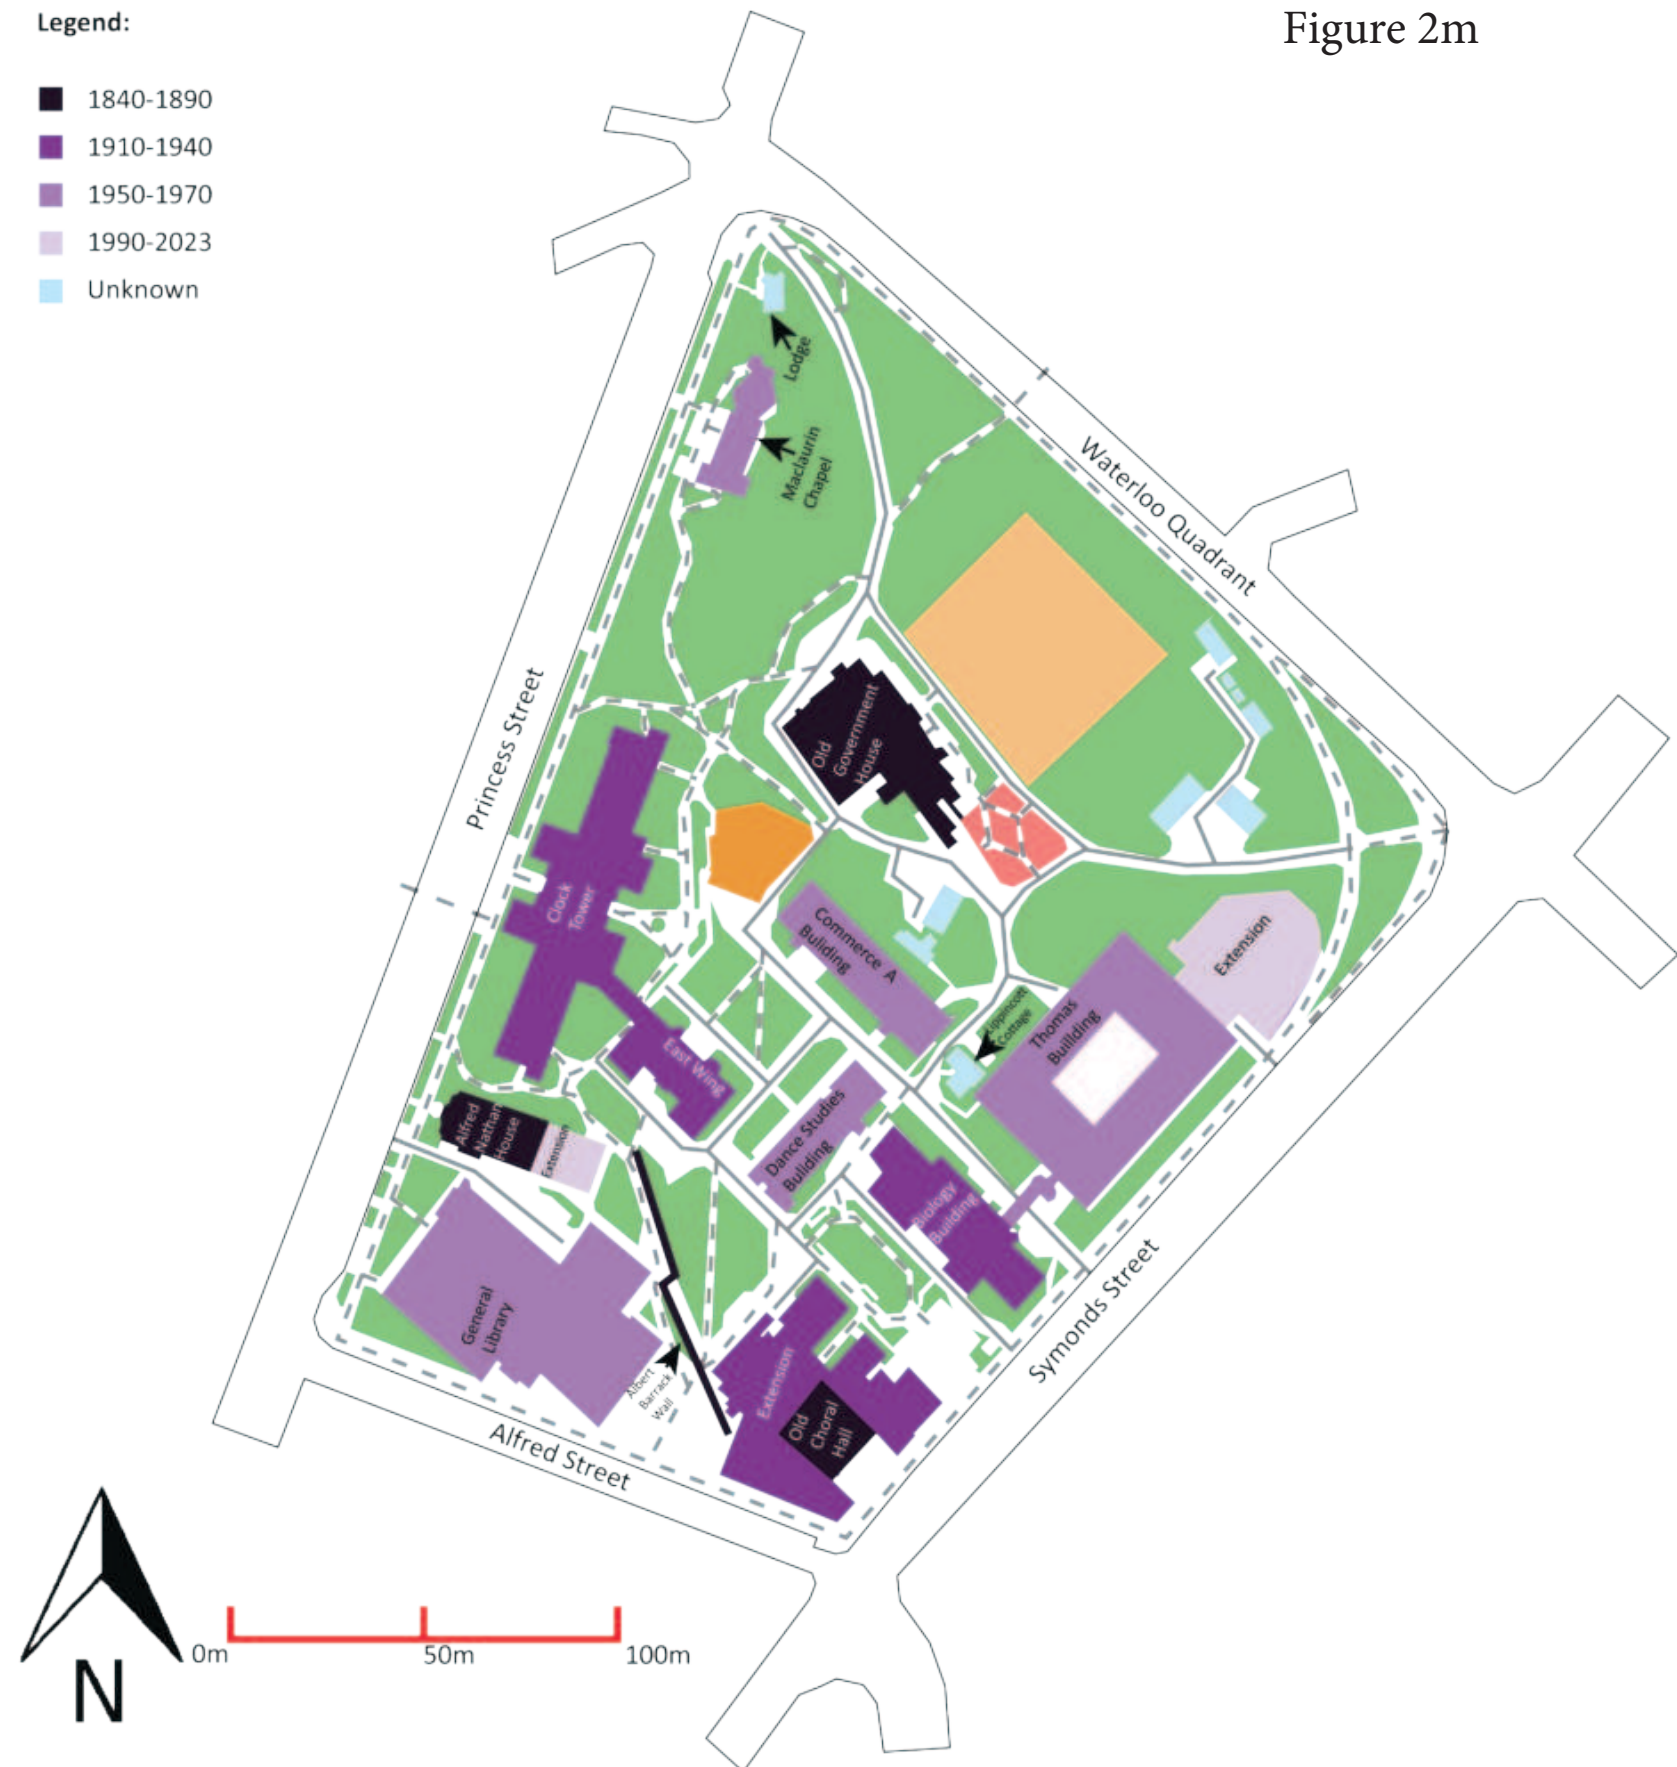
Figure 2m

Figure 2m. Map of the 100 Sector illustrating morphological periods of development. Source: (Auckland Council, 2016a; University of Auckland Business School, n.d.; Government House (Former), n.d.; Old Choral Hall, University of Auckland, n.d.; Mailhot et al., 2016; Architectus New Zealand, 2021; Old Arts Building University of Auckland, n.d.; Sinclair, 1983; Brief History of Te Tumu Herenga | Libraries and Learning Services | the University of Auckland - Libraries and Learning Services, n.d.; Thomas Building Extension, n.d.; AIPDESIGNZ - Projects - Thomas Building - Auckland University, n.d.; Personal communication, March 6, 2023) Adapted by Author.

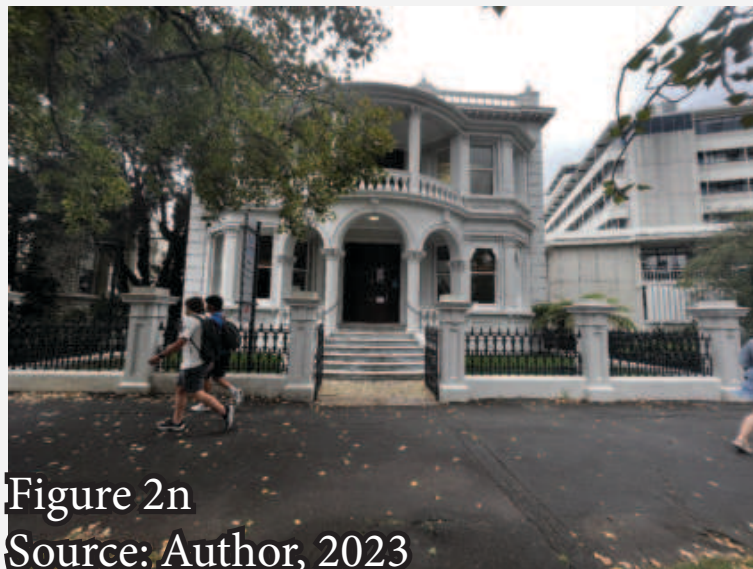
Figure 2n

The typological process occurs at the end of the cycle of a building type. New building types that supplant existing ones adapt to the preexisting built form, contend with social conceptions of building types, and act as a catalyst for new building types within the area (Gauthier, 2004). The typological process can be utilised to understand better how the 100 sector has changed. The site has seen developments throughout centuries, and building types, have changed considerably. One of the first examples of the process is the extension of Old Choral Hall. The baroque development surrounding the original building seamlessly ties in. Furthermore, the Biology Building and Thomas Building, though severely different in architectural style, blend using red, and the continuation of horizontal lines. The recent extension of the Thomas Building is another example, with the glass extension blending in with the old concrete structure with its sweeping horizontal lines. The Alfred Nathan Houses' recent expansion is another example, the new modernist rear facade is intentionally designed to not interrupt the historic front facade and tie in with the modernist general library on the back.

Alfred Nathan House Front

In 1882, Alfred Nathan House was built for prominent businessman Nathan Alfred Nathan (University of Auckland Business School, n.d.). The building currently on the site was constructed in 1906. University acquisition occurred in 1958. A fourth storey was added in 1966, and the rear was extended in 1971 (Mailhot et al., 2016). More recently, the building was restored, strengthened and saw a further extension to the rear in 2017 (Architectus New Zealand, 2021).

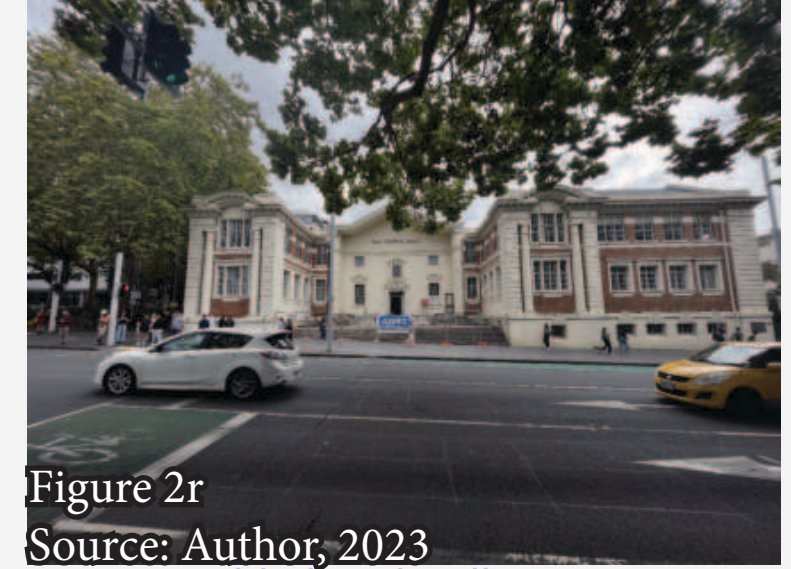
Figure 2r

Old Choral Hall Front

Old Choral Hall was built in 1872. The neo-classical structure was erected on former Government House grounds (Old Choral Hall, University of Auckland, n.d.). A baroque extension surrounding the original structure was completed in 1919. Ownership was transferred to the University of Auckland in 1907 (University of Auckland Business School, n.d.).

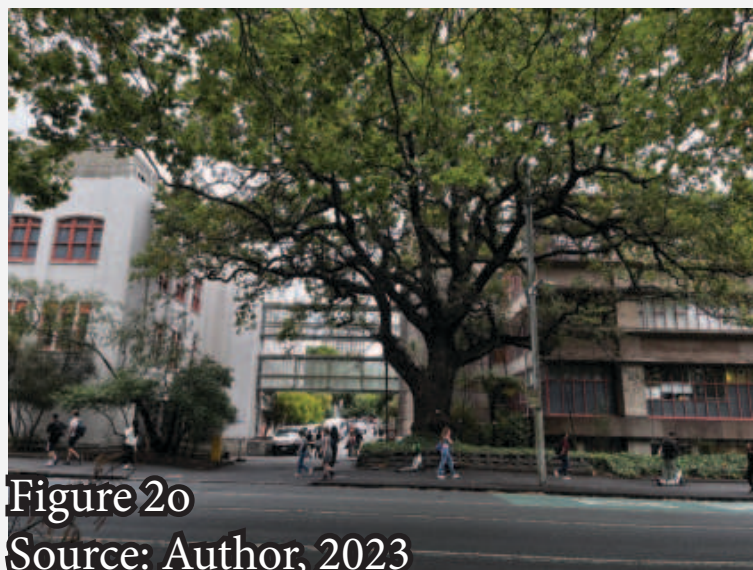
Figure 2o

Biology & Thomas Building

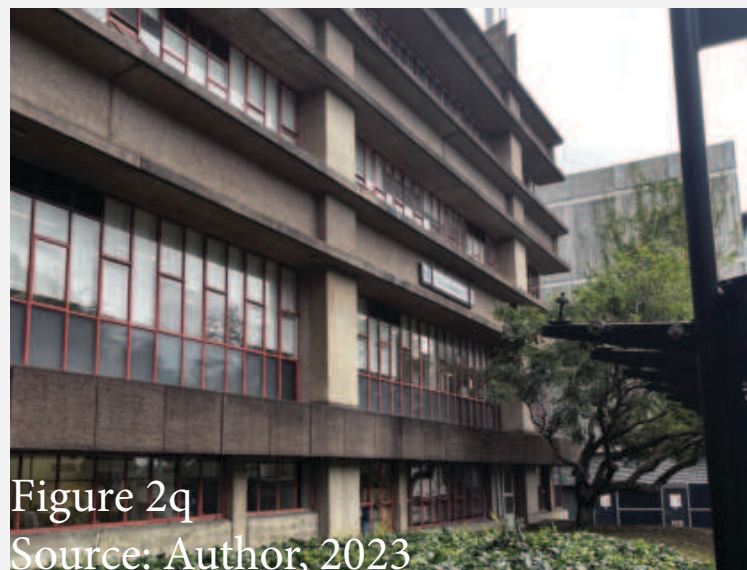
Figure 2q

Thomas Building

The modernist Thomas Building, made of concrete and glass, was constructed in 1968 (Thomas Building Extension, n.d.). In 2011 a large extension comprised of a new curved four-story building was completed (AIPDESIGNZ - Projects - Thomas Building - Auckland University, n.d.).

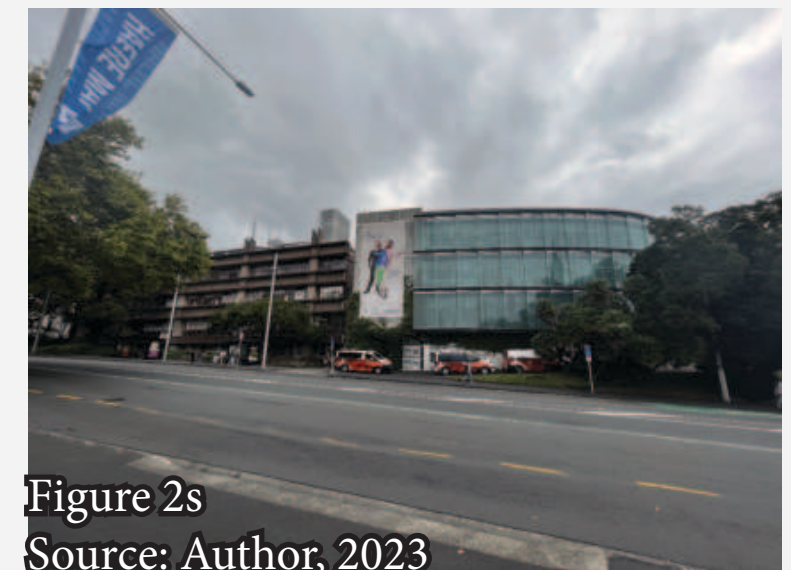
Figure 2s

Thomas Building & Extension

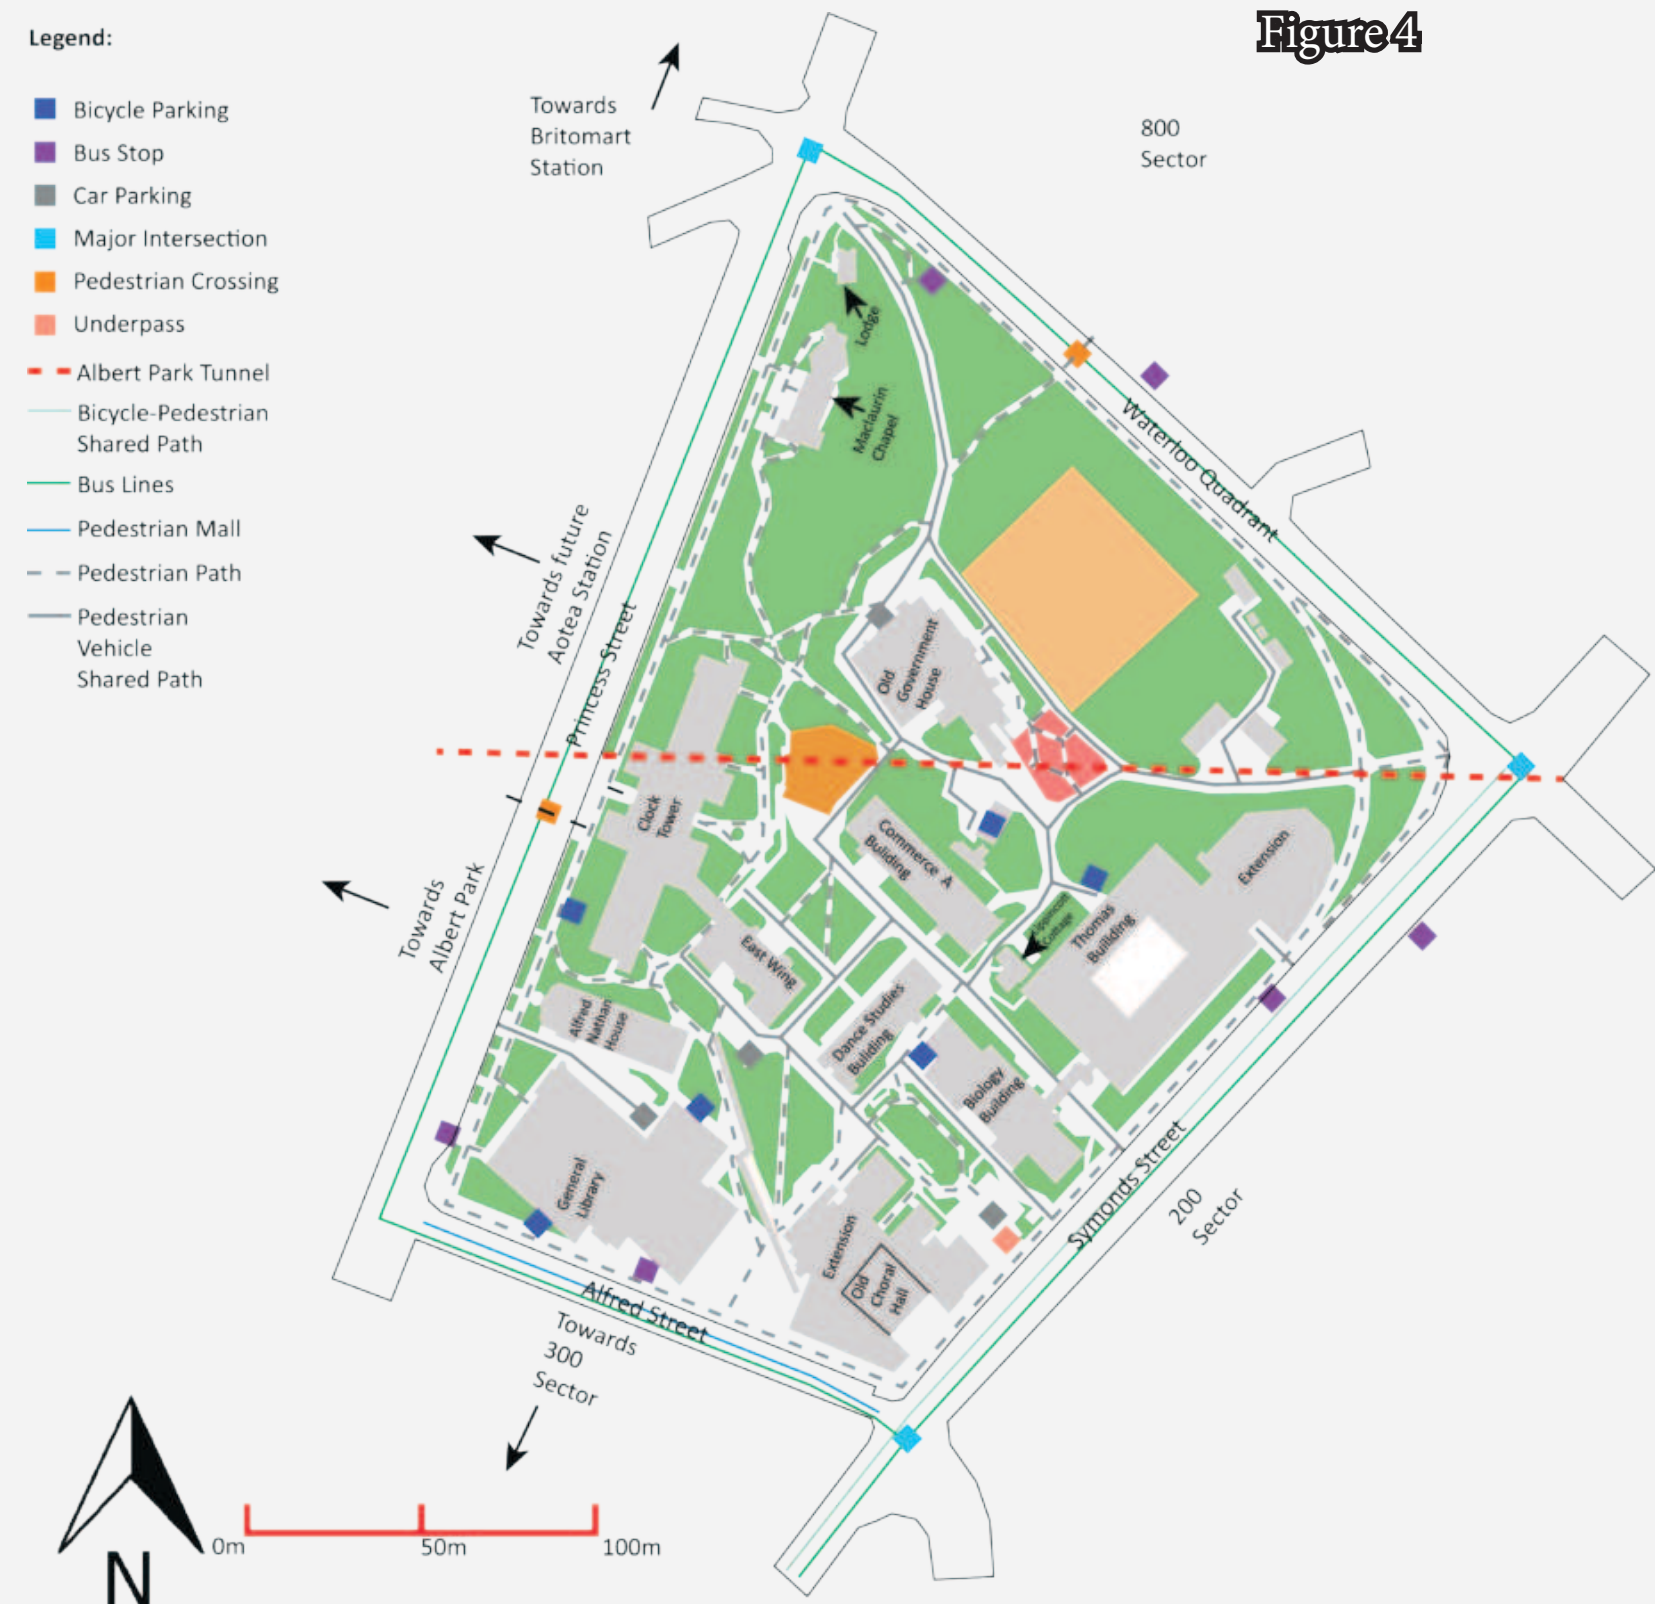
The 100 Sector is a transport hub within the city campus. Pedestrian paths, shared paths, and an underpass facilitate travel to different sectors of the university. The sector is well connected to public transport connections. Bus lines circle the site, and the nearby train lines at Britomart Station provide further travel opportunities: Authors observational studies, April 14, 2023.

The Albert Park Tunnel lies beneath the sector and could be reopened and connect to the under-construction Aotea Train Station (Auckland Council, 2020; Pilkington, S., 2007). Furthermore, a proposed station for the learning quarter on the Auckland Light Rail City Centre to Māngere line would increase the accessibility and capacity of nearby transport connections (Auckland Light Rail, n.d.).

The many shared paths make for uncomfortable pedestrian spaces and dangerous cycling paths. Shared paths could be renovated into pedestrian malls to make for more comfortable pedestrian spaces whilst preserving vehicular accessibility: Authors observational studies, April 14, 2023.

Figure 4: Map of transportation within the 100 Sector (Auckland Council, 2016a; Pilkington, S., 2007) Authors observational studies, April 14, 2023. Adapted by Author.

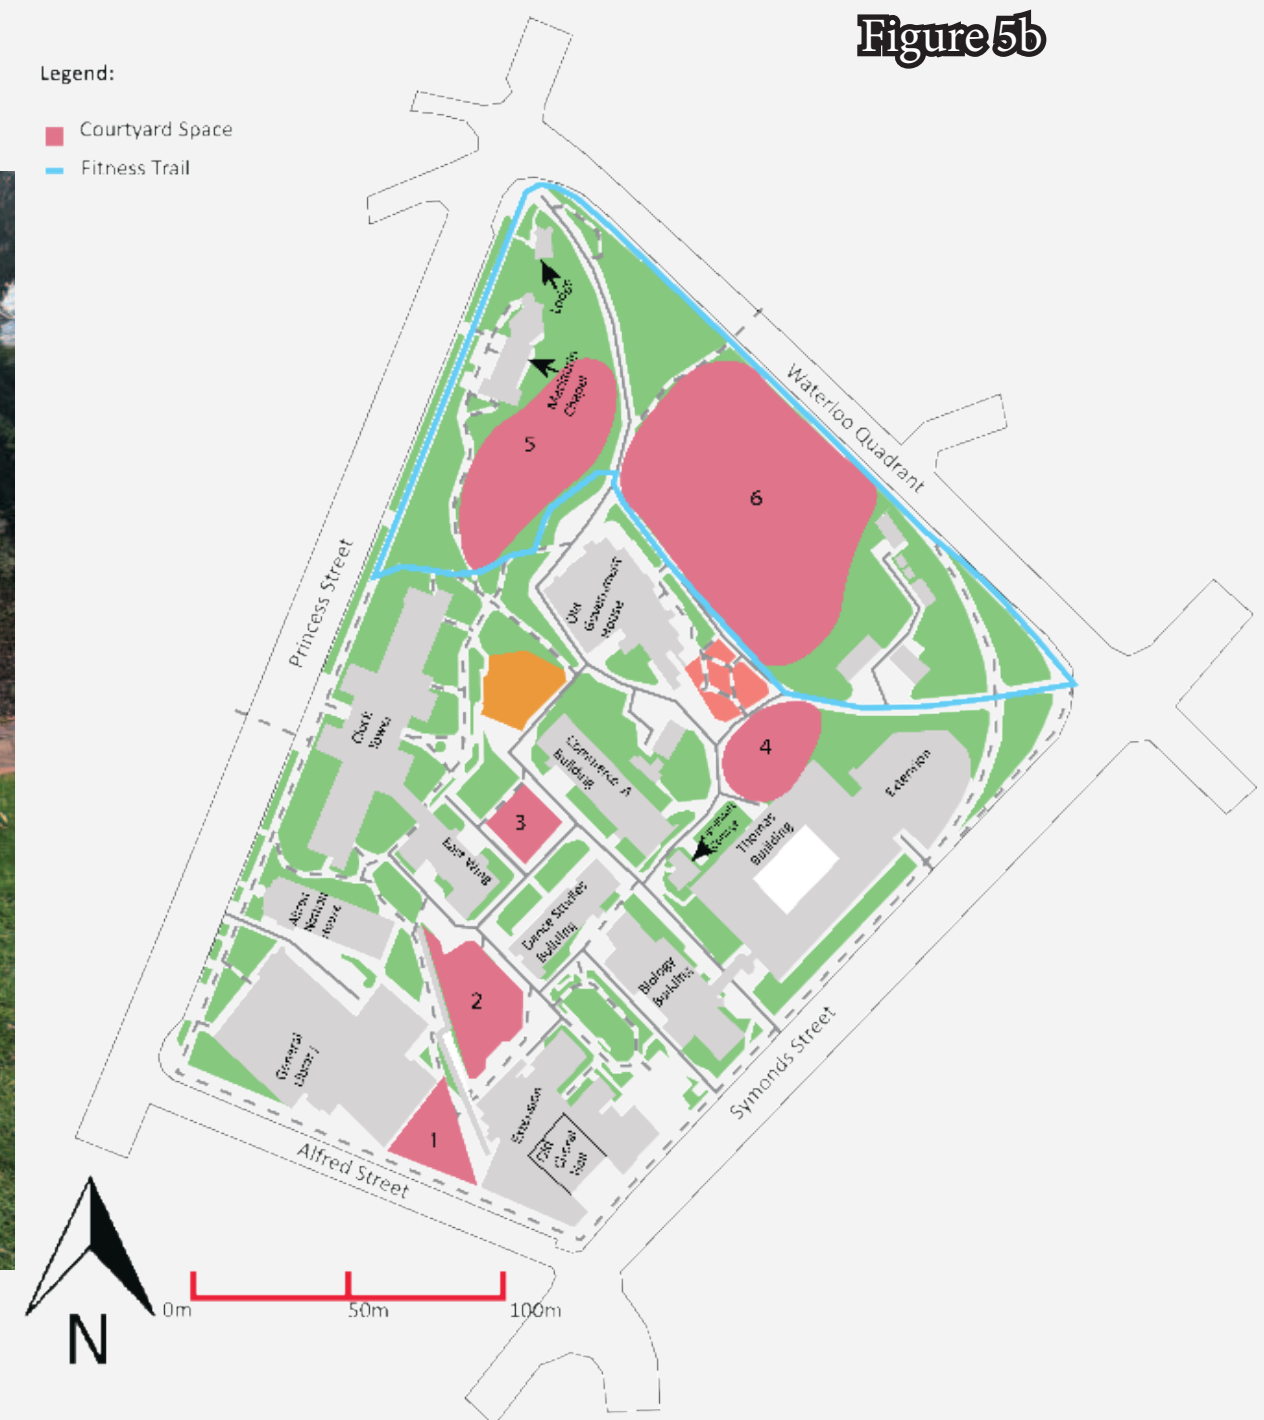
Figure 5b

Activities within the site include socialising (courtyards one and two), studying (courtyards three and six, due to the presence of tables), reading (courtyard 5) and eating occurring in most spaces, however most prominently in courtyard space 6. Some students also exercise, using the fitness trail, as seen in Figure 5b.

Figure 5b: Map of the 100 sector illustrating the position of courtyard spaces and the fitness trail. (Auckland Council, 2016a) Adapted by author. Authors observational studies, April 14, 2023.

Human scale is a vital consideration for courtyard spaces, to remain human scale the width should range between 12 meters to 25 meters (Alexander et al., 1977). Furthermore, the walls should not exceed a height to width ratio of 1:3 (Gu, K., 2023). Most courtyard spaces within the site fail to meet this standard, and remain underutilised. Most courtyard spaces contain few amenities, mainly benches. The few tables available attract more users. Furthermore, existing amenities are sometimes poorly maintained, as seen in Figure 5a, leading to underutilisation and uncomfortable spaces. Furthermore, the usage of spaces is very weather dependent due to no weatherproofing.

The relative popularity of courtyard spaces within the sector is more dependent on proximity to activity nodes. Spaces closest to the General Library, a prominent activity node, attract the most users.

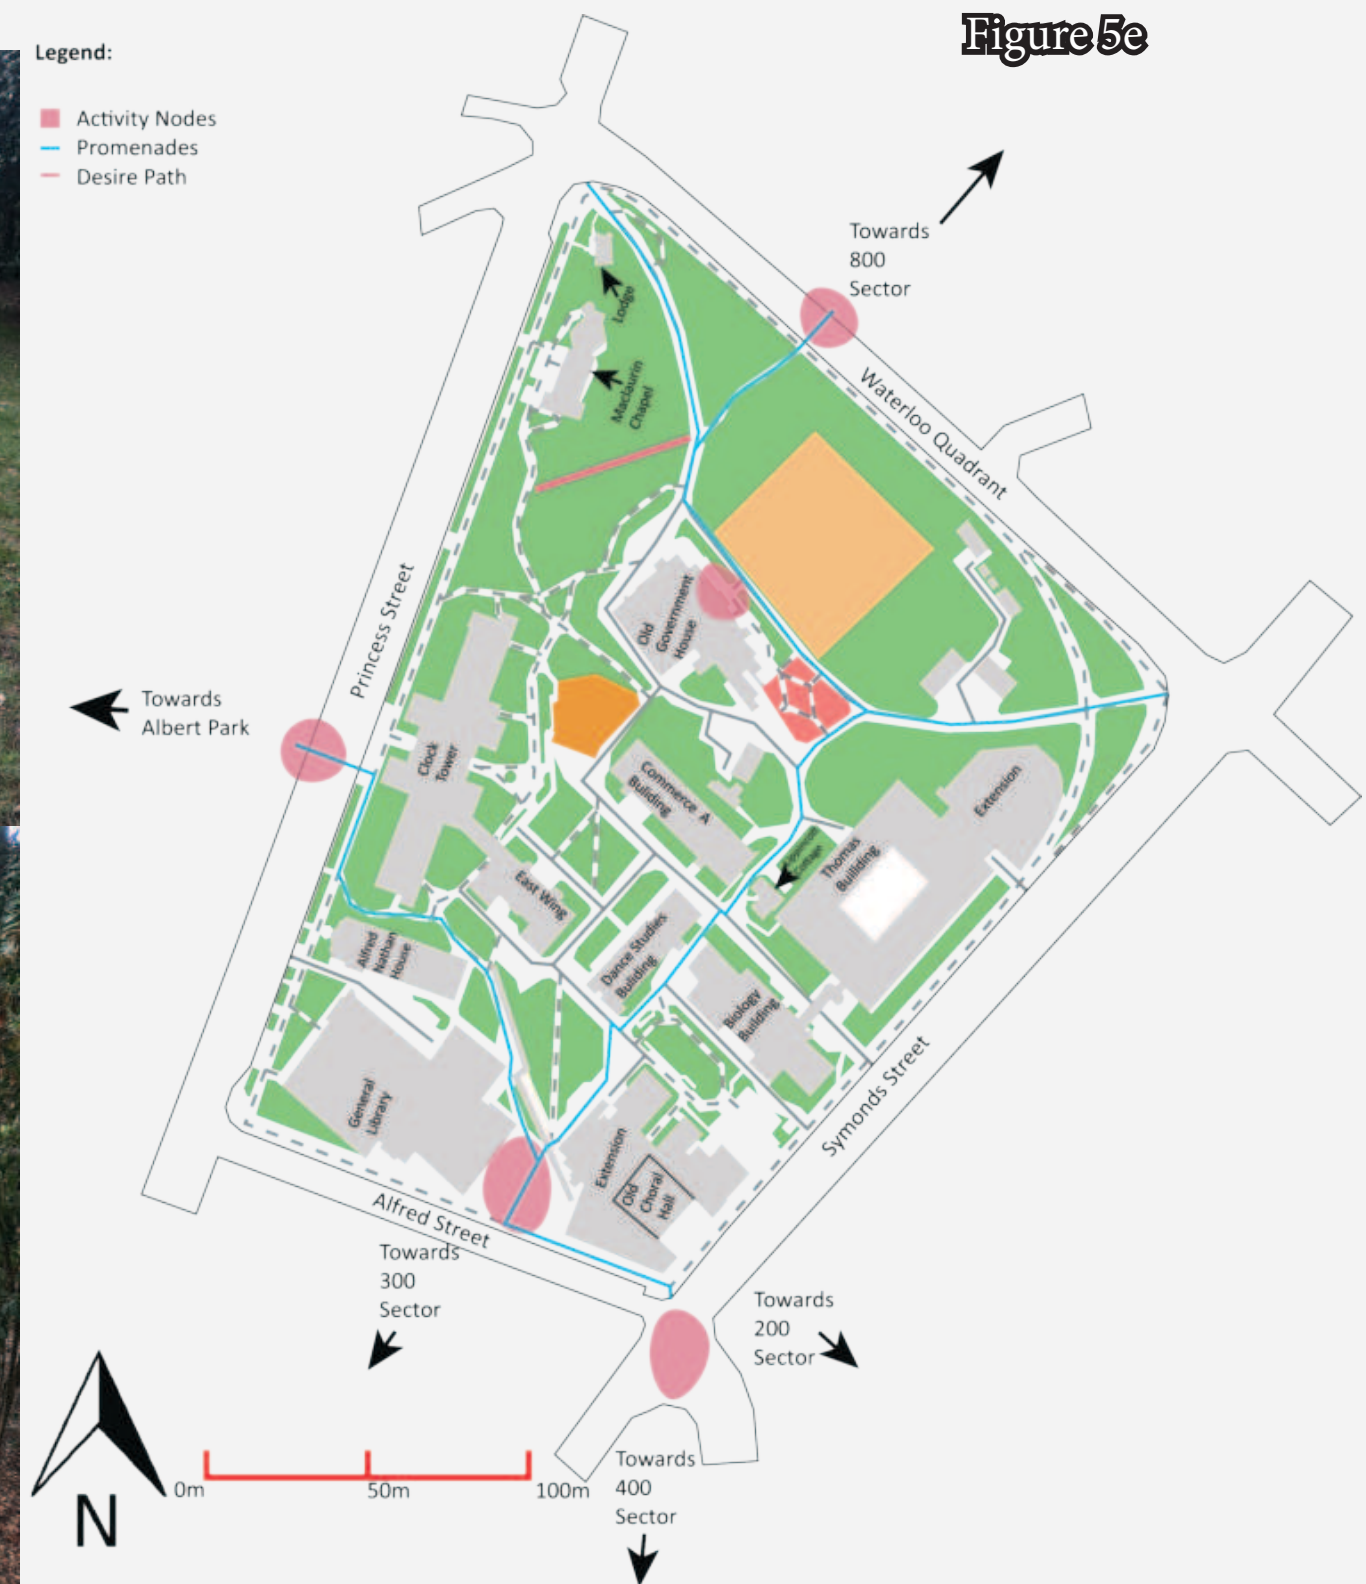
Activity nodes are areas designed to concentrate pedestrian movement (Alexander et al., 1977). Albert Barrack Wall segregates the space and only one path crosses it. Coupled with the density of students within the General Library, this creates a significant activity node. There are a variety of other activity nodes where students and staff enter the sector and leave for other sectors. Another significant activity node is the pedestrian crossing on Princess Street, allowing access to Albert Park for recreation or travel further into the city. Promenades are pathways that help form or strengthen activity nodes by facilitating pedestrians (Alexander et al., 1977). The promenades within the 100 sector radiate out of the General Library activity node and facilitate pedestrian movement to other activity nodes. However, the promenades of the site primarily consist of shared paths, which are uncomfortable for pedestrians. Desire paths are paths pedestrians have taken despite pre-existing paths, as the path is either more direct or feels more comfortable (Tomes, 2022). In the open greenery next to Maclaurin Chapel, a desired path exists going to the front of Old Government House. There are many pre-existing paths to facilitate this movement. However, these paths are poorly maintained, heavily shaded, have significant grades, and have blind corners which amalgamate in an uncomfortable space, as seen in Figures 5c and 5d. Figure 5e: Map of the 100 Sector illustrating the position of activity nodes, promenades and desire path. (Auckland Council, 2016a) Adapted by author. Authors observational studies, April 14, 2023.
